Manhole Inspection Summary

Manhole # S29AA2011MH

Location Address: **5405 CHARLES ST**

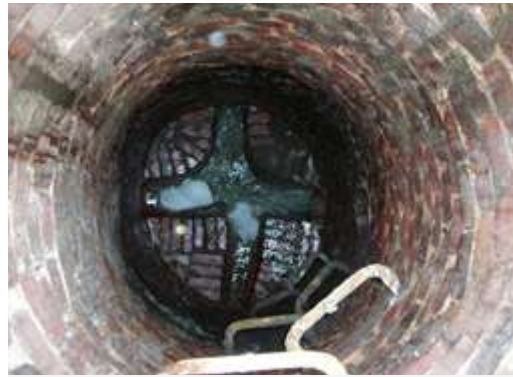
Top View

Barrel infiltration. Bench debris. Corroded steps.

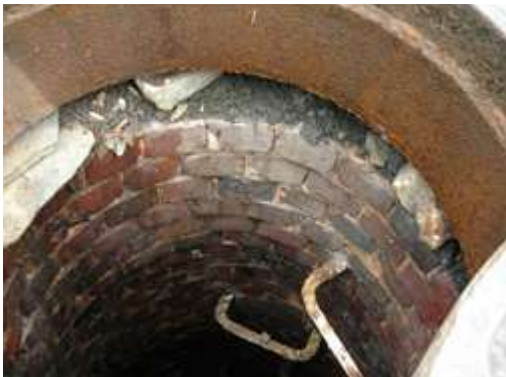
Defect

Frame leaks. Adjustment deterioration, loose brick and infiltration. Corbel infiltration.

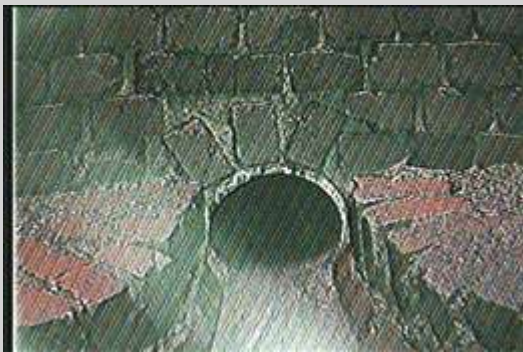
8 in. Circular Gravity Sewer Pipe Out @ 12 O'Clock

Infiltration: **Evidence** Pipe Seal Cond: **Unknown**

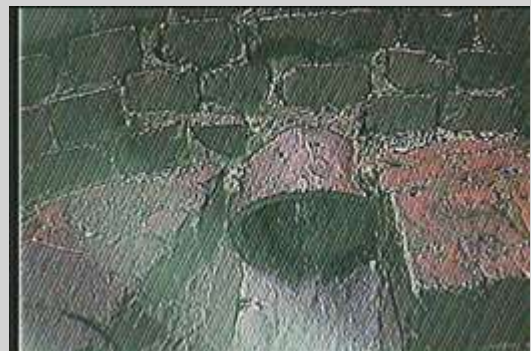
Drop In @ 3 O'Clock

Comments **The I9 Drop ext. picture shows Barrel and Channel deterioration.**

Barrel deterioration and infiltration. Bench and Channel deterioration.

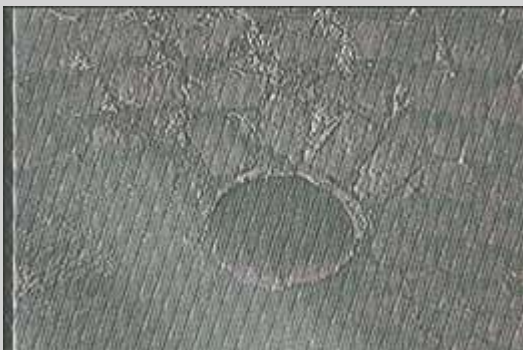
Pipe In @ 9 O'Clock

Infiltration: **Evidence**

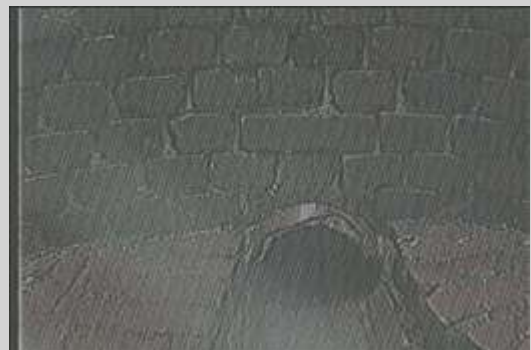
Drop In @ 9 O'Clock

Barrel deterioration and infiltration. Bench and Channel deterioration.
